## Removing Play from the Burman-Douglas Steering Box

By John Merton (based on an article first prepared for "The Morgan Ear" in 1990).

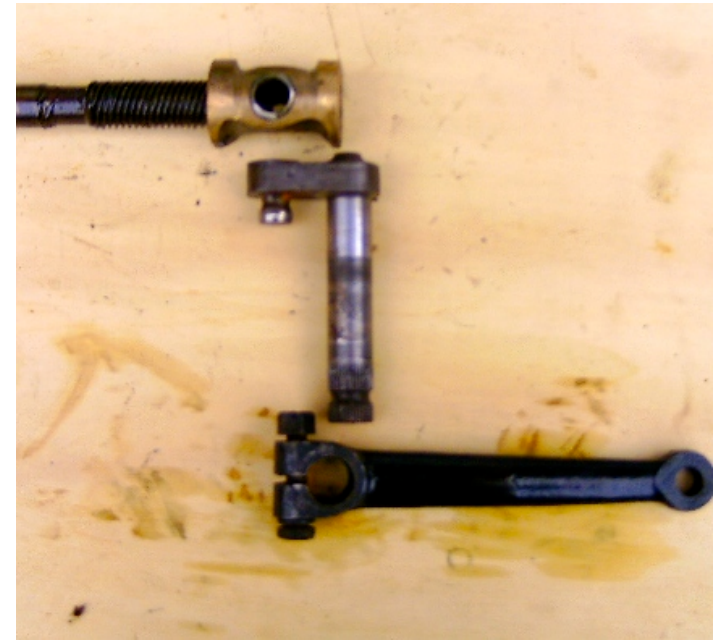
*Internals of the Burman-Douglas box. This shows the worm machined on the end of the inner steering column, the bronze nut which screws onto the worm, the rocker arm and peg which engages with the hardened steel bush in the bronze nut and the steering drop arm which attaches to the bottom of the rocker shaft*

Address wear in the thread as follows. Clean the nut thoroughly (Prepsol or similar) then tin the inside of the nut lightly with solder. Grease the thread on the shaft with a good axle grease (don't use WD 40 or similar as they may well flash) and screw the nut on, about halfway along. Melt babbitt metal, heat up the nut, and pour the molten babbitt metal down the bush hole, rotating the shaft until metal appears at the end of the nut. Keep rotating the shaft as it cools down to prevent binding.

Play between the nut and the side of the box is addressed similarly ie by building up the sides of the nut with babbitt metal and machining to be a tight sliding fit in the box. Addressing other areas of wear, eg in the drop arm shaft bushes, should be straightforward.

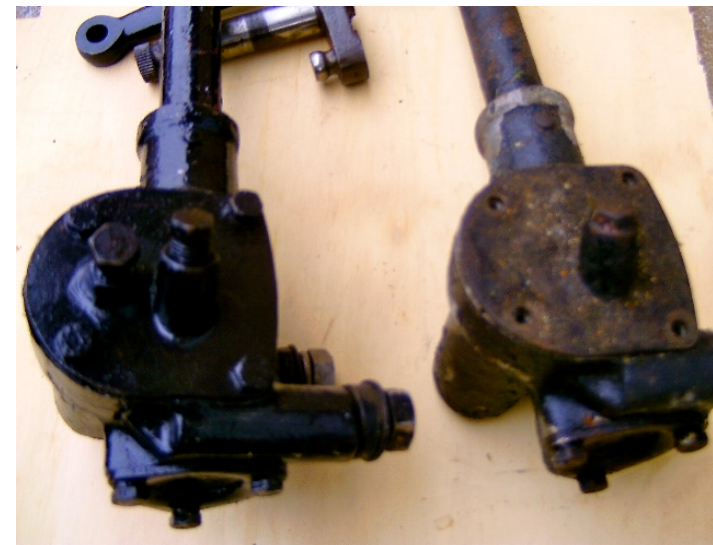
Something to watch for is that some replacement nuts are undercut on their topsides where the steel bush goes. If you strike one of these, the peg can jump out of mesh when the wheel is turned, and you will have either to add an adjuster screw to the top cover to hold it down and/or pack out the bottom of the rocker arm for the same effect.

*Top covers. Some replacement bronze nuts (they were available from several different manufacturers) had an undercut hardened steel bush. The cover on the left shows the later addition of a screw in bolt to stop the peg on the rocker arm jumping out of mesh with the bronze nut as the steering wheel is turned.*

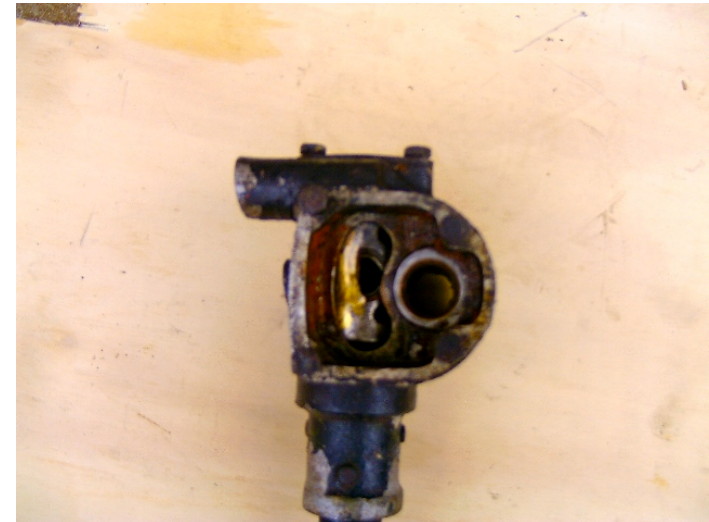
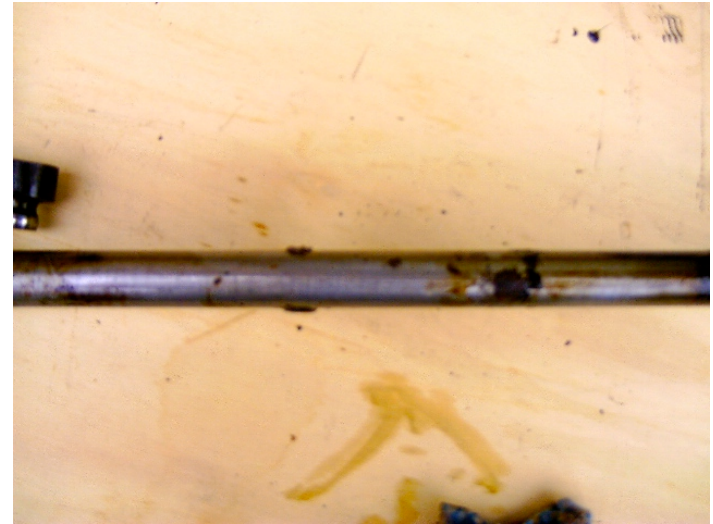
*Dodgy practices. The first photograph shows that someone has added bits of shim sheet to try to take up wear between the bronze nut and the steering box casing. The second photograph, likewise aimed at reducing play caused by such wear, has involved welding spots around the inner column and filing them down to make the column a tight fit in the outer column.*
